**A ROAD DAMAGE INVENTORY
FOR
THE UPPER DESCHUTES RIVER BASIN**

By
Steven Toth

JANUARY 1991

A Final Report
Submitted to the **SHAMW** Committee.
by
Steven Toth
January, 1991

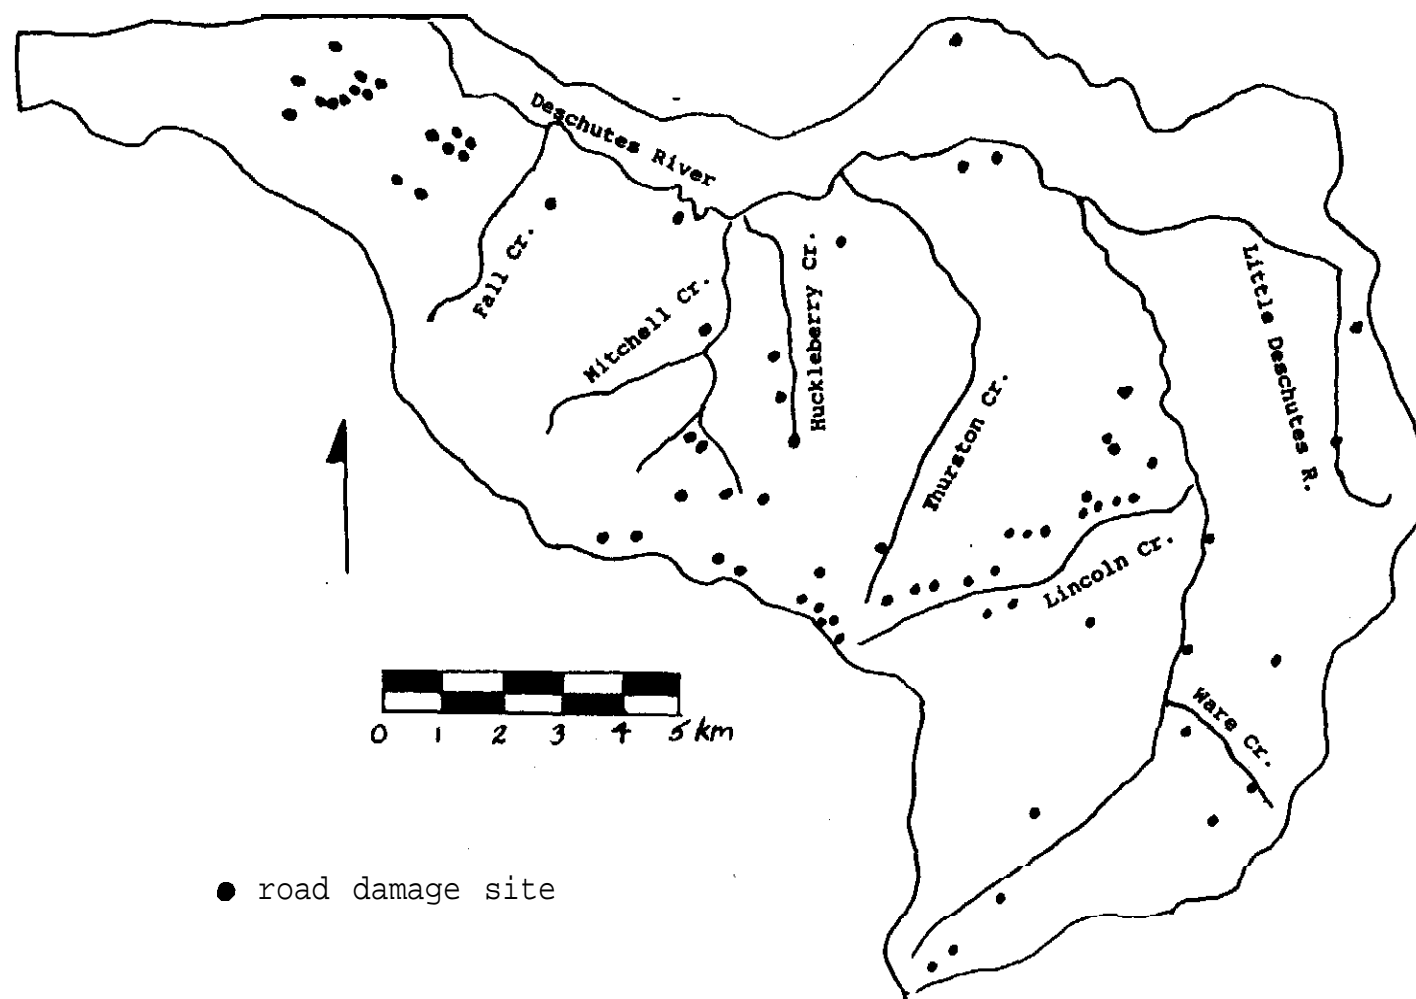
Figure 4. Location of Sample Road Damage Sites

A total of 76 road damage sites were evaluated for this study (see figure 4). The sites were chosen by the Vail Tree Farm road engineer. Since there were hundreds of sites that incurred varying degrees of damage, a sample of them needed to be taken. The sites, however, were not catalogued in any way, and therefore were simply chosen from memory by the engineer. Statistical analysis of the data was not possible because this was not a random and non-biased sample, but the information could still provide insight into the various types of problems in the watershed. The engineers felt it was a proportionately representative sample including most of the larger and more obvious problems that caused serious damage, as well as the smaller and less serious damage sites. Many of the sites had been repaired by the time of this study, making it difficult at times to accurately assess the causes for failure. The engineers, though, were able to provide the necessary information to evaluate the site conditions prior to repair work.

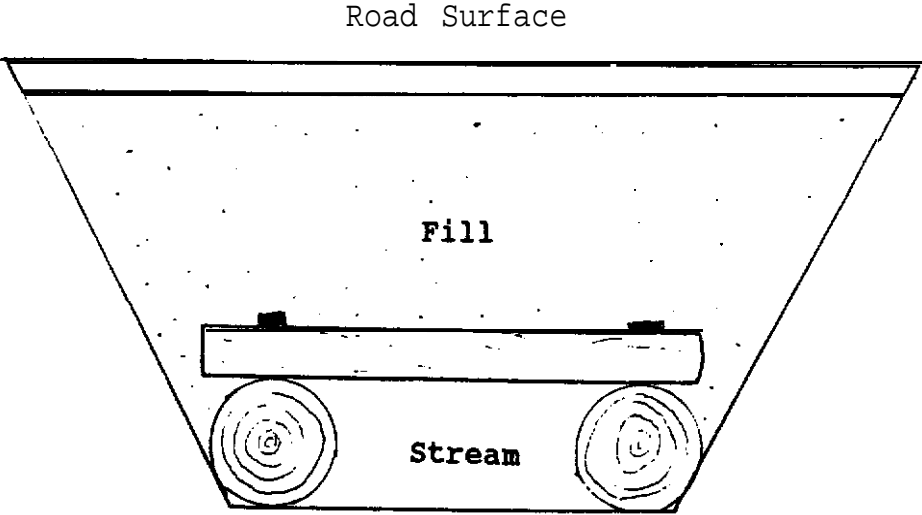
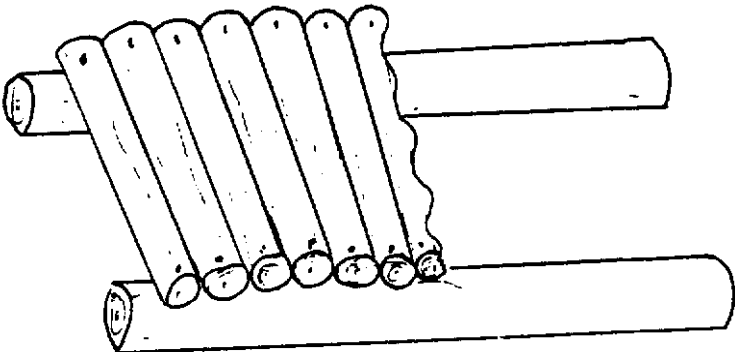
Figure 8. Cedar **Puncheon** Culvert

Culverts were the next most significant problem accounting for 29% of **the** damage sites. Stream culverts represented 22% and relief culverts 7% of the sites. Nearly half of the stream culvert problems involved cedar **puncheon** culverts, all of which caused some environmental damage. Eighty-one percent of the stream culvert problems caused significant environmental damage. The major cause of culvert problems was blockage of culverts (68% of the cases).

Culvert size is an important consideration presently because many of the older culverts need replacing. The cedar **puncheon** culverts were predicted to last **25-30** years (Siversides, 1949) and their replacement with steel culverts is long overdue. Many of these culverts have been replaced, but many remain in place. Considering the potential for environmental damage when they fail, replacing cedar culverts should be the top priority.

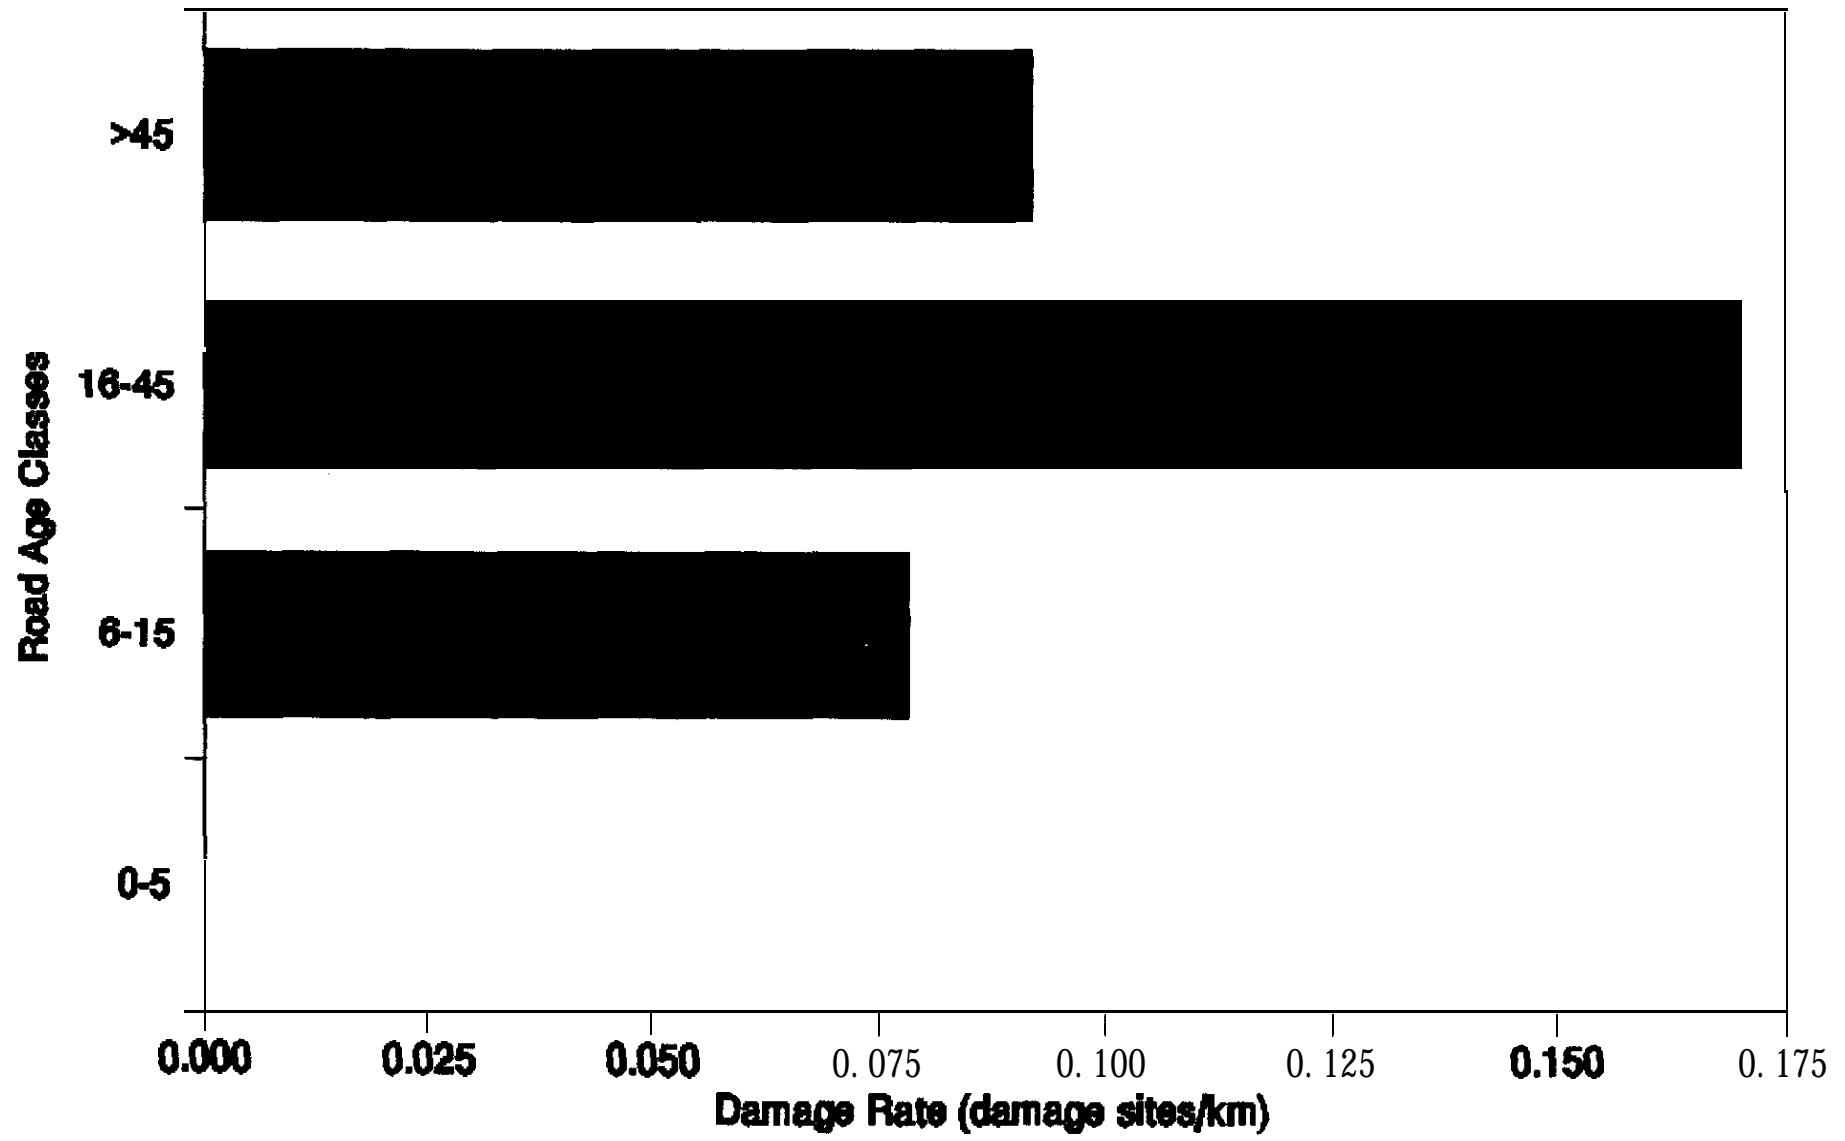
Figure 9. Damage Rate by Road Age Class

Combining the information from the age class map and road damage form showed significant differences in the damage rate between road **age classes** (see figure 9 and table 1). There was no damage to roads built in the last five years. Roads built from 6-15 years ago averaged .078 damage sites/km. Roads built from 16-45 years ago averaged .170 damage sites/km. Railroad grade roads averaged .092 damage sites/km. All of the damage on railroad-grade roads occurred in partially-reconstructed sections.

The road age category with the highest damage rate, **.170** damage sites/km, was the 16-45 year group. Most of the problems occurred with steep cutslopes and with culverts, but shoulder failures and road slumps were also significant problems. Averaging a damage site every 5.8 km, these roads should be a prime candidate for some reconstruction.

The oldest age class **of** roads built over 45 years ago had a moderate damage rate of **.092** damage sites/km, similar to the 6-15 year age class. The moderate damage rate is probably due to the partial reconstruction of these roads. If the **puncheon** culverts had been replaced during reconstruction, these roads would have had very few damage sites. Another reason for the lower damage rate is that the old railroad grades are on rather flat terrain where we would naturally expect less problems **with soil** movement.

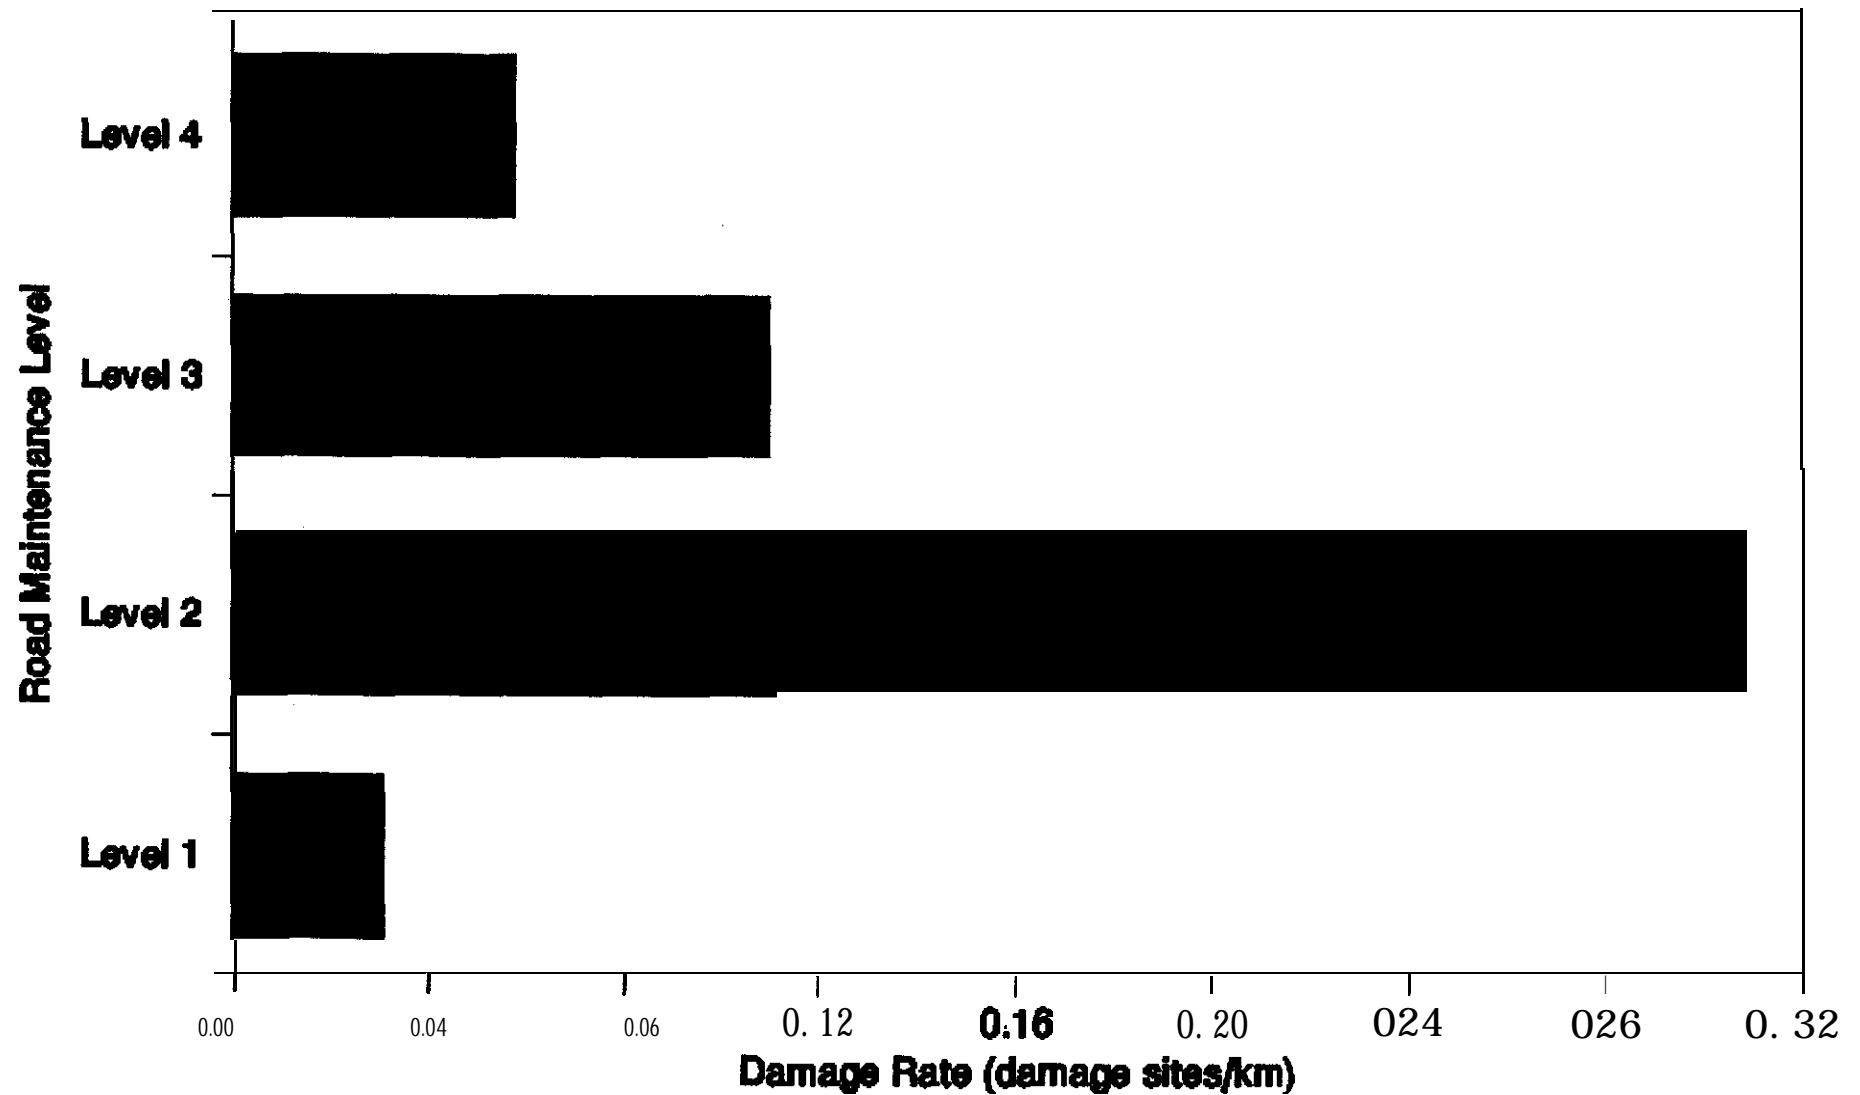
**Figure 12. Damage Rate by Road
Maintenance Category**

Examining the information from the maintenance level map and the road damage form showed significantly different damage rates for each maintenance category (see figure 12). Level 1 roads averaged .031 damage sites/km, while level 2 roads averaged .308 damage sites/km. The damage rate for level 3 roads declined to .110 damage sites/km and for level 4 roads declined further to .058 damage sites/km.

One would expect the damage rate to decline progressively as maintenance increases, but level 1 roads seem to present an anomaly with its very low damage rate. One reason could be that most of

While the number of problems directly due to poor maintenance was low (17%), the fact that there is a progressive decrease in damage rate with better maintenance levels indicates it is of some importance. There is no record of how much damage was prevented by better maintenance, but the difference in damage rates between level 2 and 3 maintenance shows it was significant. One reason why railroad-grade roads might have fared better than expected was because they were all at either level 3 or 4 maintenance. This fact helps support the need for having a good road maintenance system.

Future road damage might be prevented if maintenance levels were based on sensitivity to problems, rather than just the amount of road usage. The sensitivity of a road could be addressed by considering some combination of road age and physical terrain

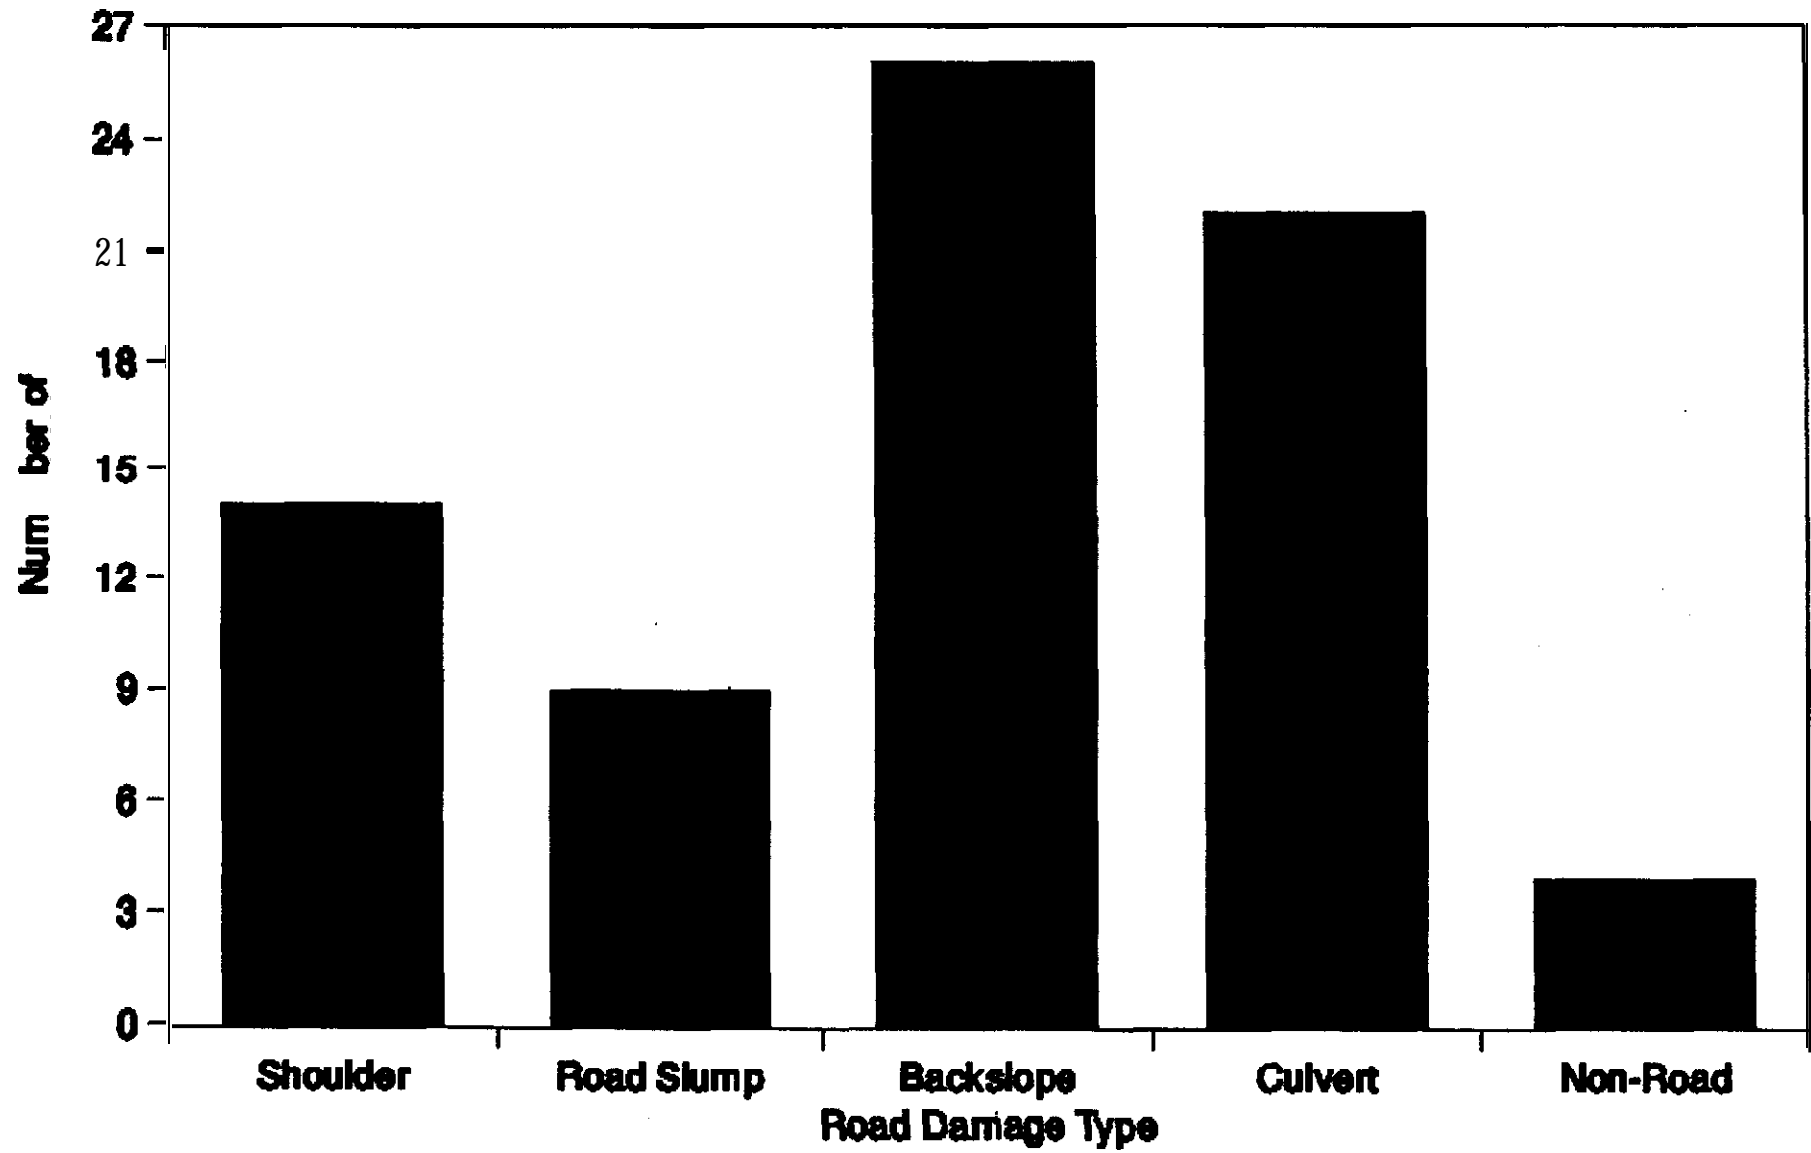
Figure13.Frequency of Road Damage Types

Figure 13 contains the frequency distribution of the different types of road damage. The largest number of problems (34%) were located in the backslope. Of these failures, 65% were due to steep cutslopes. The average cutslope angle for all backslope sites was 43.7 degrees. The presence of unstable soil significantly contributed to failures in 58% of the cases. Unstable soils were defined as either coarse grained granitic soils or weathered volcanic soils with a high clay content that occurred on slopes exceeding 35 degrees. These areas usually had a past history of slides that were visible on the surrounding hillslopes.

Steep backslopes accounted for the most road damage of any of the different failure types. The cause of this seems to be steep cutslope angles in areas of unstable soil. This was especially apparent in the Lincoln Creek watershed. Many times the failures would simply land on the road and just needed to be cleared away. Just as often, however, they blocked a ditch or culvert and more serious damage resulted.

Shoulder failures were another important problem comprising 18% of the sites. Excess sidecast on steep slopes was a significant factor in 93% of the shoulder failures. The average fill slope was 38.9 degrees. Twenty-nine percent of the failures caused significant environmental damage.

Road slumps accounted for only 12% of the sites. Seventy-eight percent of the problems were due to inadequate drainage. Unstable soil and fill on steep slopes were significant causes in 67% of these sites. One-third of the sites were responsible for environmental damage.

Reducing the cutslope angle in areas with unstable soils and a history of failures would be of great help. Much of the road system, though, has problems with steep cutslopes and it is not very practical to reduce the angle of every slope. Another more feasible alternative would be to pull the ditches out a bit so that

small failures and cutbank raveling do not immediately cause problems. Also, maintaining a good crown on the road would keep excess water from flowing onto sidecast material and reduce the chance of failure.

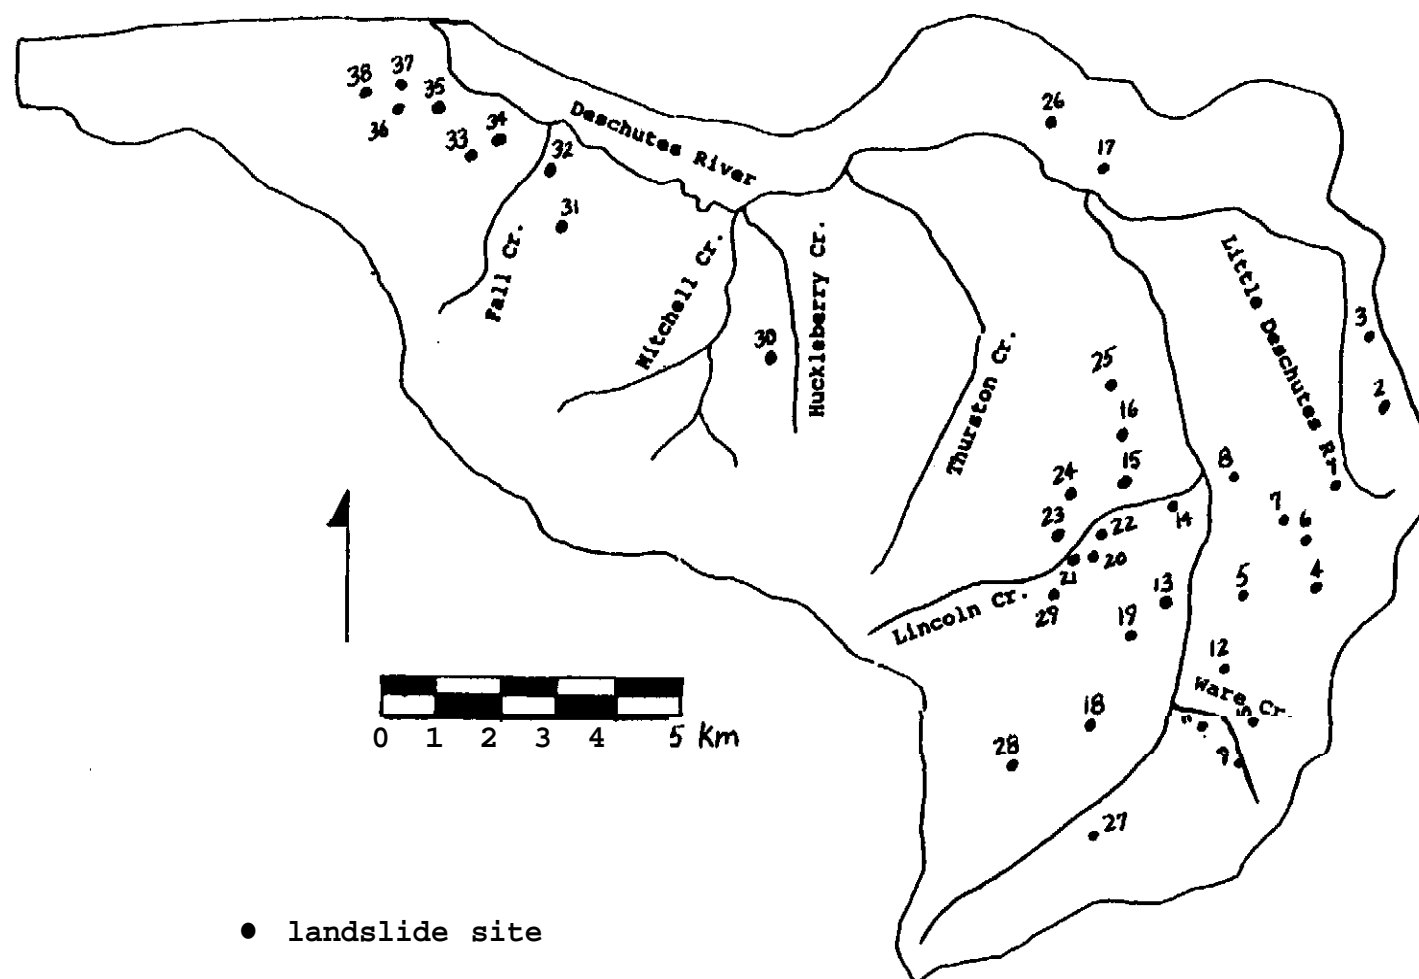
Figure 14. Landslide Inventory Sites

The landslide inventory data contained similar information to that collected in the road damage survey, but since the landslide inventory was a complete, non-biased sample, it was possible to do some statistical analysis. Figure 14 shows the location of the landslides and table 3 summarizes other information collected in the inventory. Two-thirds of the landslides in the sample were road related. There was no significant correlation between the origin of failure and the frequency of stream entry. The frequency of stream entry for both road and non-road related failures was approximately 60%.
